# Manhole Inspection Summary

Manhole # S45II\_015MH

Insp Date: **4/30/08 11:23 AM**

**Location** Address: **Gay St**

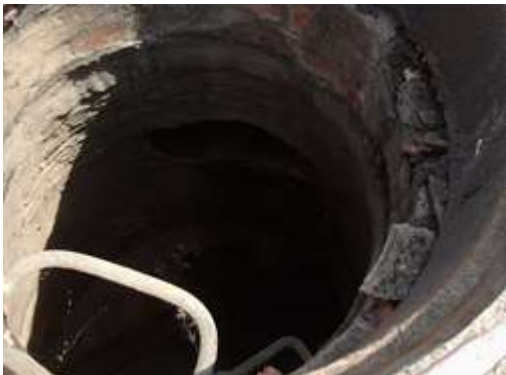
Defect 1

Infiltration: ☐ None ☐ Joint ☐ Cracks ☒ **Mortar** ☐ Roots ☐ Wall

infiltration

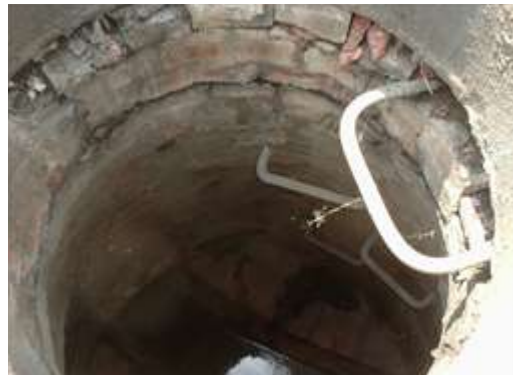
Defect 2

Condition: ☐ Sound ☐ Cracked ☐ Root Intrusion ☒ **Loose Brick** ☐ Deteriorated

deterioration

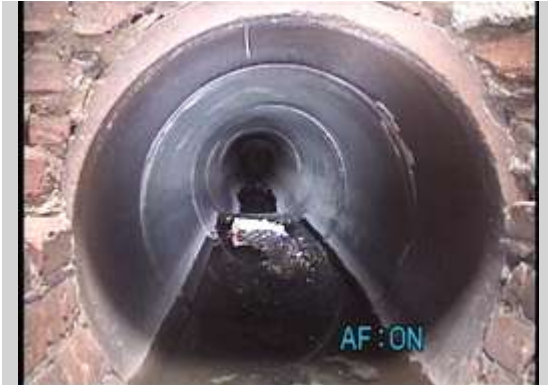
12 O'Clock Outflow

21 in. Circular Gravity Sewer  
Pipe Out @ 12 O'Clock

Pipe Height: **21.6** (in.) Rod and Bar (Angled)  
Pipe Material: **Clay** ☐ Pipe Lined  
Invert Depth: **9.30** (ft.) Flow Characteristics: **None**  
Deposits: ☒ None ☐ Mud ☐ Sludge ☐ Debris ☐ Grease  
Silt Depth: (in.) Deposits Extent:  
Infiltration: **None** Pipe Seal Cond: **Sound**

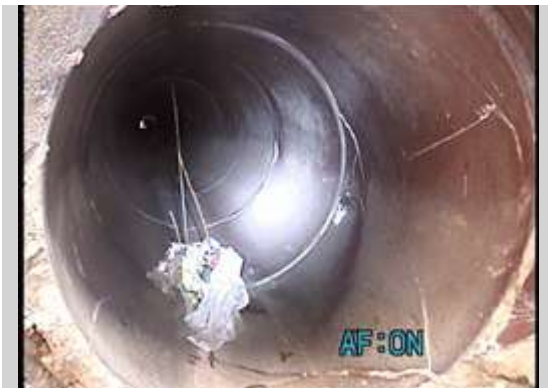
4 O'Clock Inflow

21 in. Circular Gravity Sewer  
Pipe In @ 4 O'Clock

Pipe Height: **21.6** (in.) Rod and Bar (Angled)  
Pipe Material: **Clay** ☐ Pipe Lined  
Invert Depth: **5.20** (ft.) Flow Characteristics: **None**  
Deposits: ☒ None ☐ Mud ☐ Sludge ☐ Debris ☐ Grease  
Silt Depth: (in.) Deposits Extent:  
Infiltration: **None** Pipe Seal Cond: **Sound**

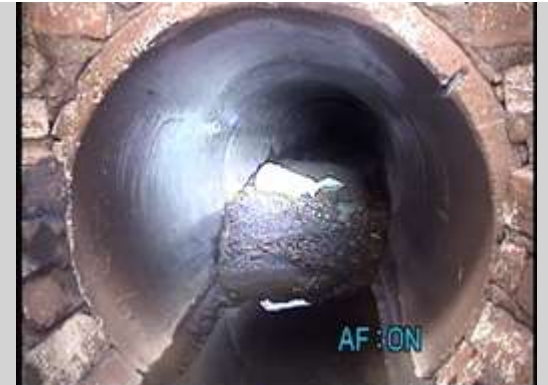
6 O'Clock Inflow

18 in. Circular Gravity Sewer

Pipe In @ 6 O'Clock

Infiltration: **None**

Pipe Seal Cond: **Sound**

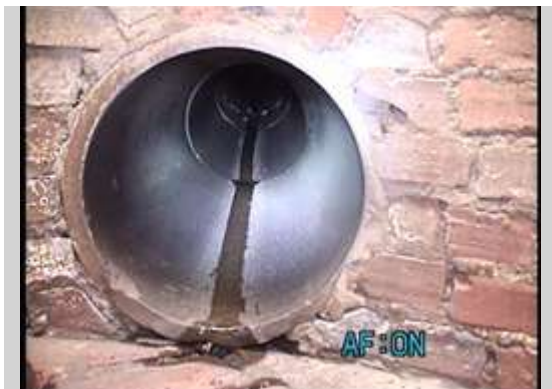
7 O'Clock Inflow

12 in. Circular Gravity Sewer

Pipe In @ 7 O'Clock

Infiltration: **None**

Pipe Seal Cond: **Sound**
